Accident Investigation Board Denmark

Bulletin 2023-502

Accident to OY-HFS (Robinson R44 Clipper II) 0.9 nm east-southeast of Kolding/Vamdrup (EKVD) on 4-10-2023

ISSUED AUGUST 2024

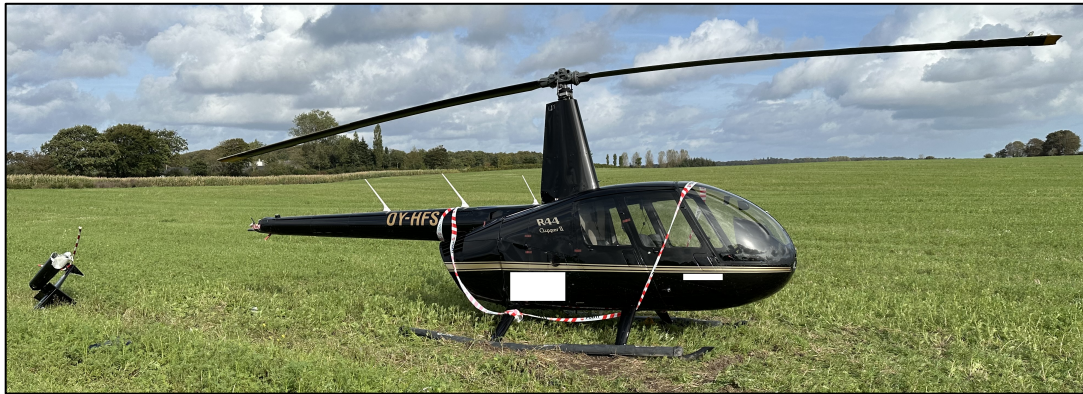
The helicopter sustained substantial damage to the following parts:

- The landing gear skid was bent.
- The firewall/bulkhead.
- The main rotor blades.
- The tail boom.

Figure 1. Damage to the helicopter (the AIB has removed logos on the helicopter)

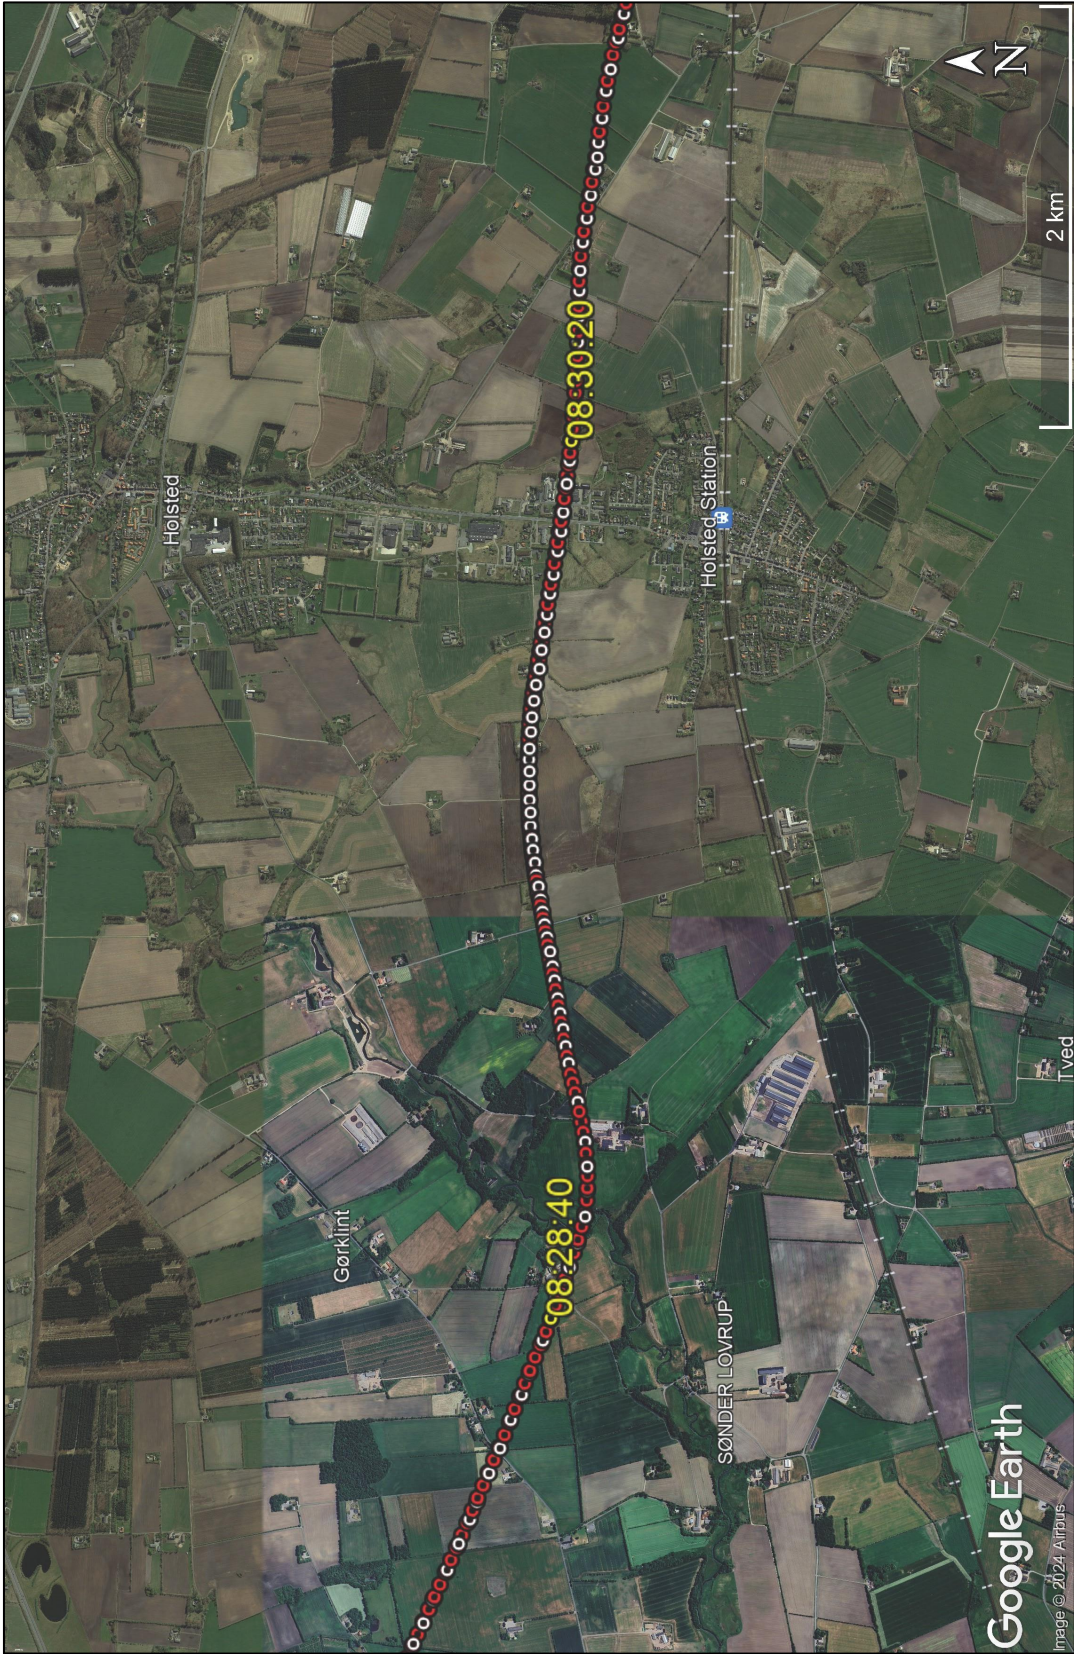
Appendix 3 Flight track plot RPM underspeed event

The RPM underspeed event ([appendix 3](#) and [appendix 4](#)) lasted for about 20 seconds and the main rotor RPMs were below 70%. Despite low weight of the helicopter, this was very close to a catastrophic (unrecoverable) main rotor stall (which can occur below 80% rotor RPM).

A proper response to the low rotor RPMs, according to the POH, would be to lower the collective and open the throttle with the grip handle. The manifold pressure remained low for about 10 seconds. It seems likely that the pilot eventually managed to open the throttle to recover the RPMs before the governor resumed automatic control (above 80%). The pilot did not select the governor switch to off during this sequence.

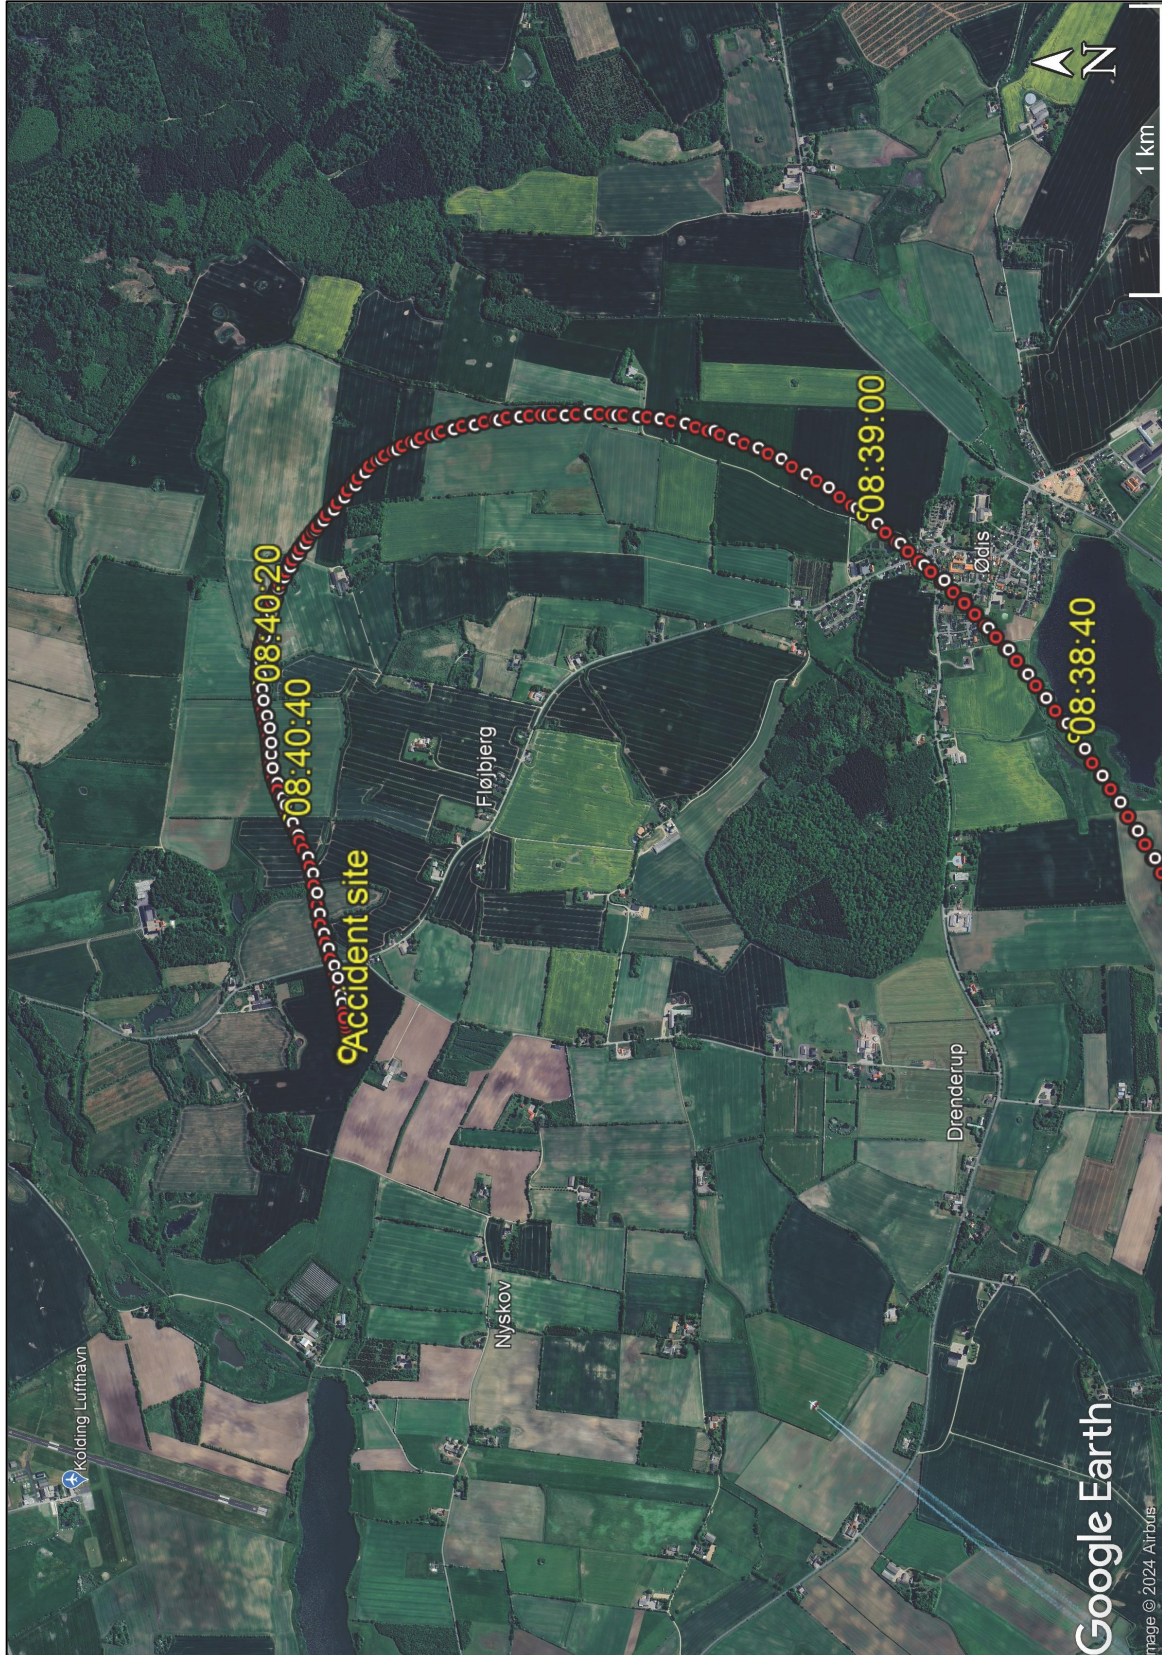
Appendix 5 Flight track plot RPM overspeed event

Data ([appendix 5](#) and [appendix 6](#)) indicated that a minor overspeed (below 108%) occurred during the LH base turn to runway 25 (over the city of Ødis). The RPM governing was resumed and remained normal for about 100 seconds until the major RPM overspeed event occurred after turning final to runway 25.

The major overspeed initiated at approximately 120% RPM. The pilot apparently did not attempt to control the RPMs (by switching governor off and closing the throttle) but immediately initiated a descent/autorotation. During the late part of the descent (at approximately 500 ft), the throttle/manifold pressure was reduced, and the engine RPMs went below 110%. Shortly after (6-7 seconds at 08:41:00 hrs and 350 ft) the throttle was increased and RPMs exceeded 125%. This sequence repeated once more just before impact.
