Accident Investigation Board Denmark

Bulletin 2023-502

Accident to OY-HFS (Robinson R44 Clipper II) 0.9 nm east-southeast of Kolding/Vamdrup (EKVD) on 4-10-2023

ISSUED AUGUST 2024

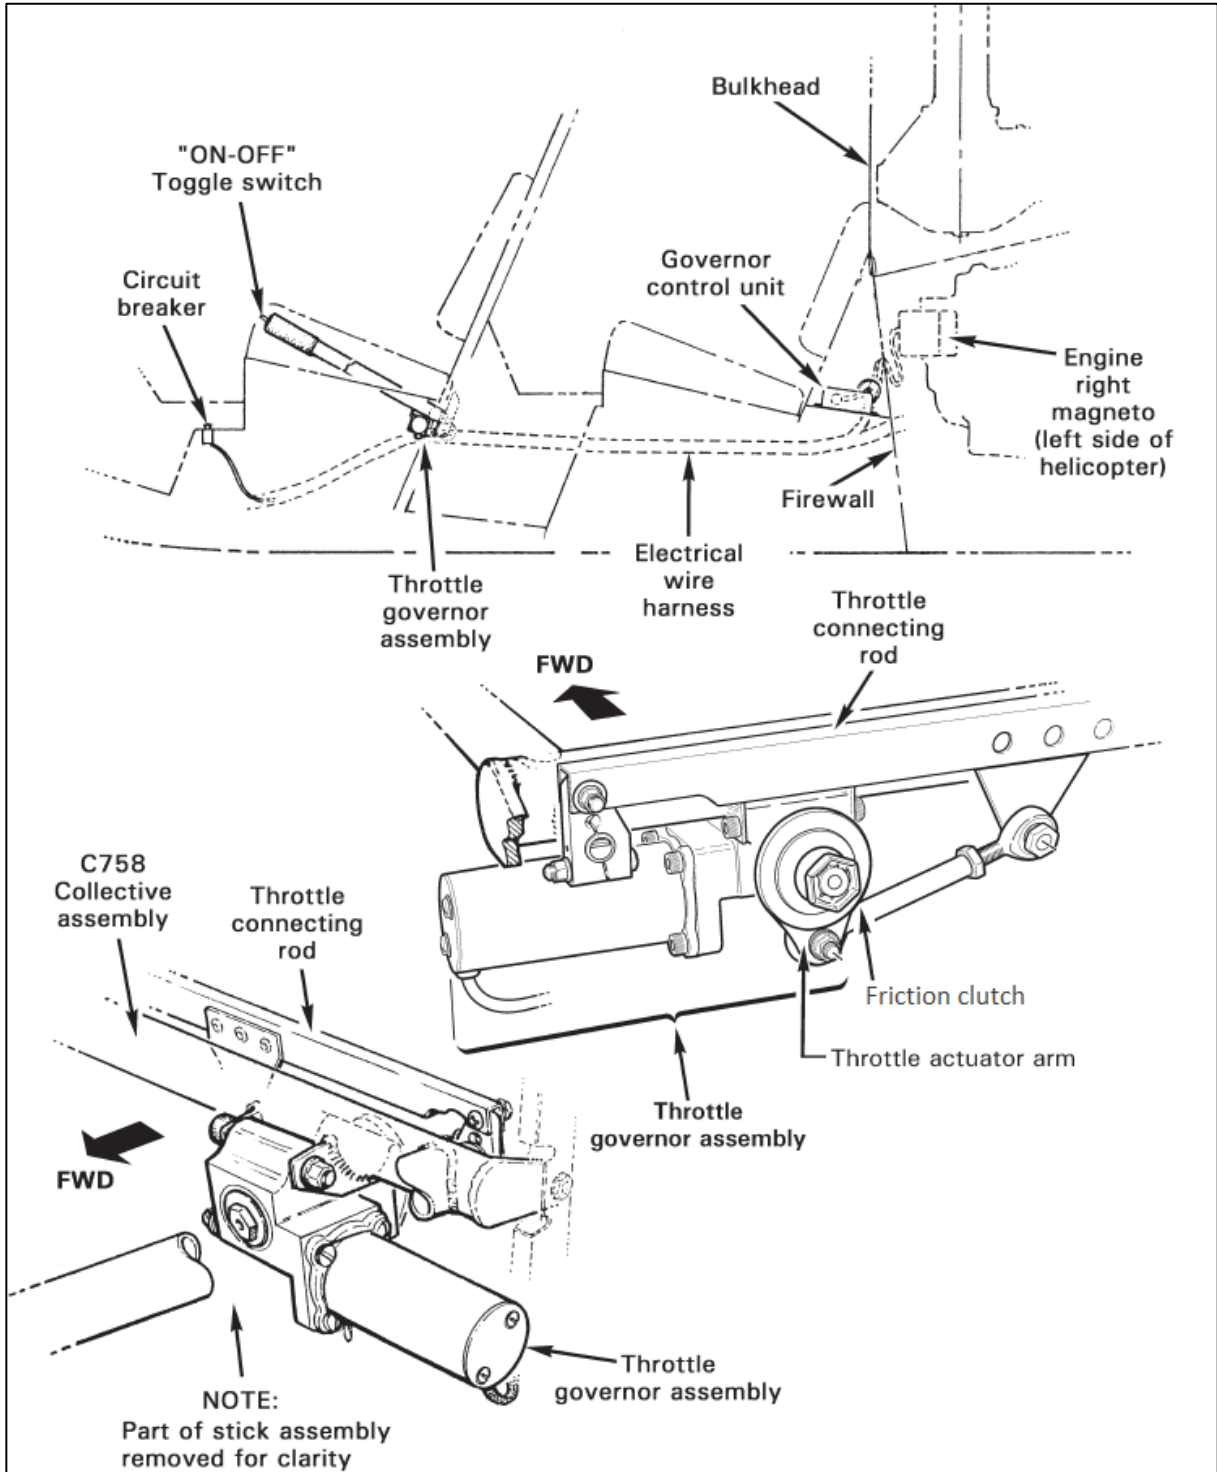
Appendix 2 R44
Throttle and Collective
control system

The on-site technical investigation of the collective and throttle control system did not identify any deficiencies. All linkages were in good working condition.
